# **Aspergillus in the Blood Collection Environment; an investigation**

**S.Pearce**

09/2014

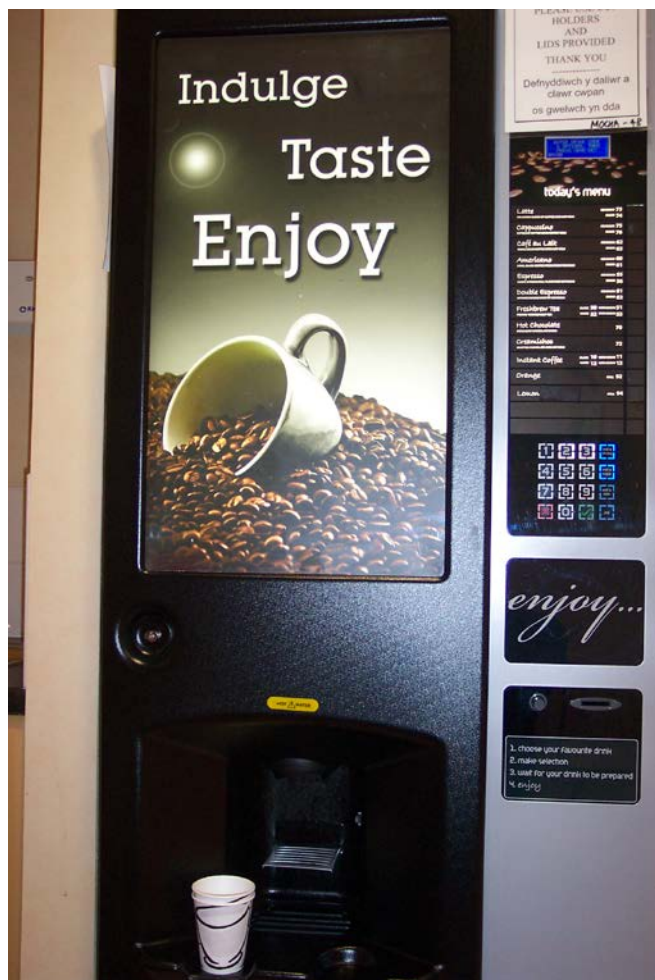
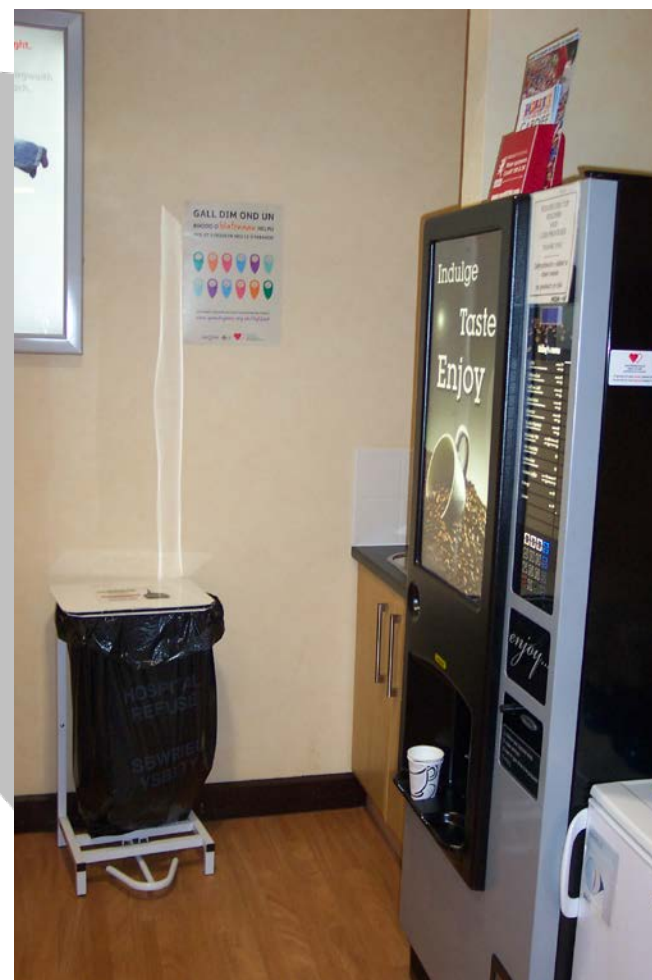
## Coffee machine & Bin

- Sat in clinic, plates every 15 minutes, notes every 15 minutes with what happened
- Clinic quiet, staff left, all plates no growth 😞
- After clinic emptied, positive plates occurred when coffee vending machine emptied

- Coffee machine uses ground coffee beans which are discarded into a waste bin within the machine
- This waste emptied into bin next to coffee machine
- Contamination Spikes occurring when bin was emptied (Monday AM) and when coffee Machine was emptied (Friday PM)

- Bin changed (no longer solid bottom)
- Protocol for emptying coffee machine agreed with contractor
- Aspergillus disappeared!
